# Manhole Inspection Summary

Manhole # S29II\_018MH

**Location** Address: **1601 MCMECHEN ST**

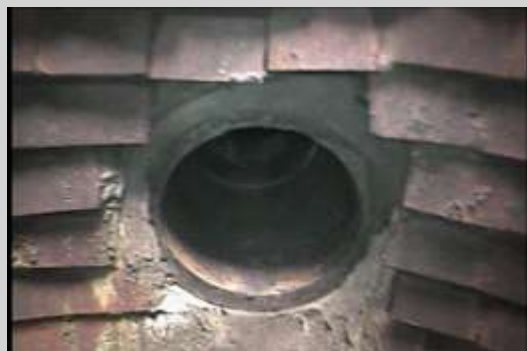
Pipe In @ 9 O'Clock

Infiltration: **Evidence** Pipe Seal Cond: **Unknown**

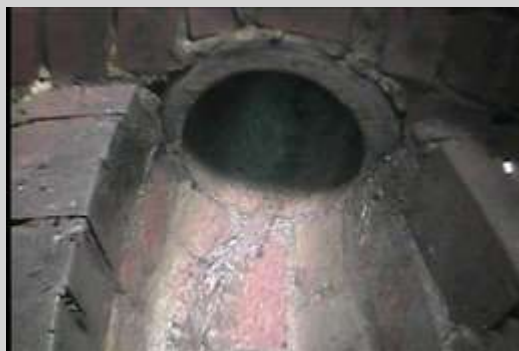
Drop In @ 9 O'Clock

Drop: <b>Outside</b>	<b>Rod and Bar</b>
Angled: <b>Yes</b>	Reading: <b>6.29</b> (ft.)
	Inv Depth: <b>7.29</b> (ft.)
Drop Condition: <b>Open</b>
